SAMPLE HEAT LOSS REPORT

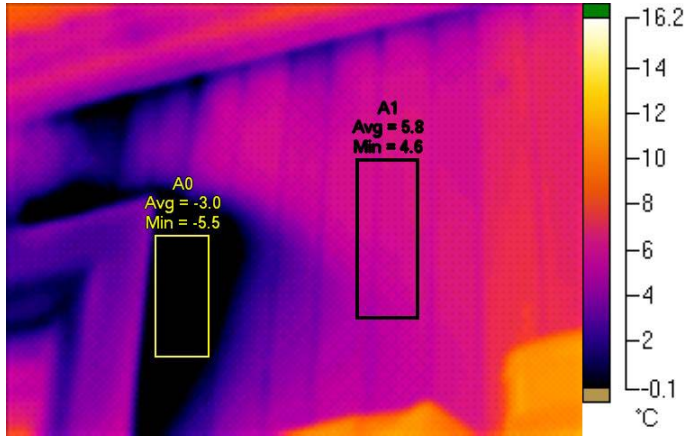
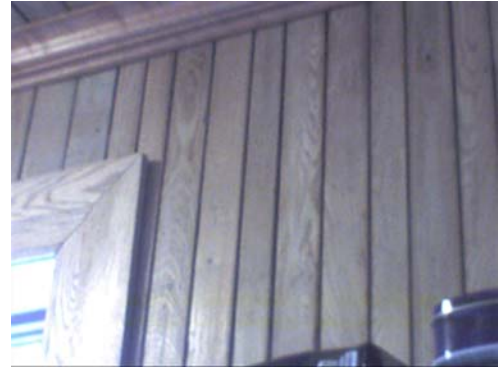
Visible Light Image

This is a very cold room and there are significant air leaks all around the patio door.

Name	Avg	Min	Background
A0	-3.0°C	-5.5°C	9.3°C
A1	5.8°C	4.6°C	9.3°C

The average cold temperature in the top right corner air leak is -3.0C. We recommend removing the patio door trim and determining whether spray foam can be applied to seal air infiltration.

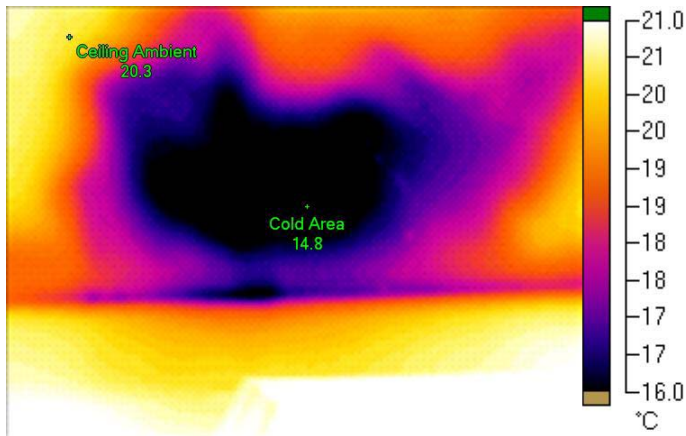
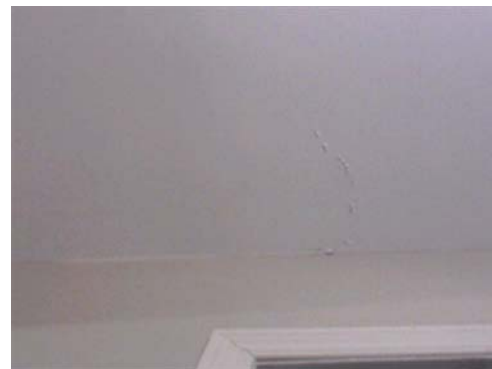
Visible Light Image

This image is a view of the bathroom ceiling taken from the floor. The cold area is due to missing insulation.

Name	Temperature	Background
Cold Area	14.8°C	20.0°C
Ceiling Ambient	20.3°C	20.0°C
